# A Study of Hydrogen Evolution During Aqueous Oxidation of Mild Steel

June 6, 1969

**NAVAL RESEARCH LABORATORY**  
**Washington, D.C.**

## A STUDY OF HYDROGEN EVOLUTION DURING AQUEOUS OXIDATION OF MILD STEEL

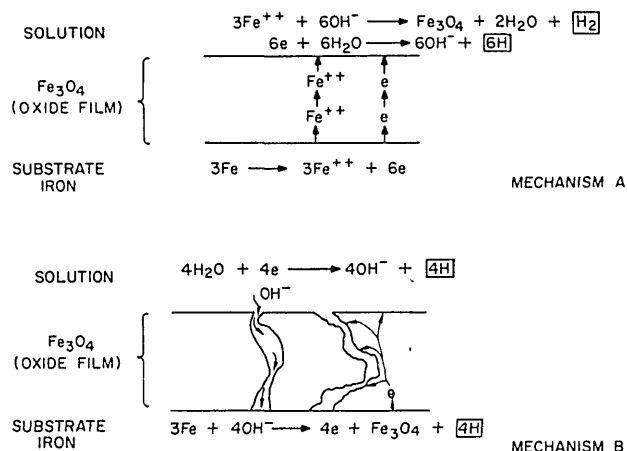
As is usually the case in corrosion problems, one has an electrolytic system in boiler corrosion. The water and its contained ionic species are the electrolyte, the iron is the anode, and the oxide film assumes the role of cathode as it forms. To simplify the situation under discussion, the assumption is made that one has an anaerobic system and a pH in the alkaline region. Two suggested alternative mechanisms are diagrammed in Fig. 1. In mechanism a, with no pores in the oxide film, all the hydrogen is liberated on the solution side of the growing oxide film, but in mechanism b, hydrogen is formed on each side by virtue of corrosion at the bottoms of pores. It seemed that an experiment

Fig. 1 - Suggested boiler corrosion mechanisms

Figure 1 shows two suggested variations in the corrosion process which would result in different hydrogen partitioning. Mechanism "a" depicted in Fig. 1 might be expected to result in pushing much, if not all, of the hydrogen through the palladium diaphragm. This is clearly not in accord with the observations. Mechanism "b" depicted in Fig. 1, on the other hand, would seem to call for a large amount of hydrogen to penetrate the capsule wall, either by direct permeation of atomic hydrogen generated at the base of a pore or by the development of molecular hydrogen within a pore and its subsequent migration to and through the metallic surface at the pore base. This seems consistent with the data and indicates that a porous structure in which the porosity increases with increasing alkalinity. There are, however, certain considerations which indicate that mechanism "b" in Fig. 1 cannot be the full story. Thus, if the total reaction were of mechanism "b", all the magnetite would be formed at the bases of pores. The approximately two-to-one ratio of volumes of oxide to metal, however, would generate large stresses not consistent with the development of adherent films (2). A mechanism which might account for the development of  $\text{Fe}_3\text{O}_4$  without much stress (Fig. 4) is one which calls for the occurrence of both processes in pores: mechanism "a" at the pore surfaces and mechanism "b" at the bases.

However, one can see another possible mechanism for relief of film stress consistent with the flow of most of the hydrogen through the metal wall. If one assumes that reaction takes place by mechanism "b" of Fig. 1, it may be noted that the solution within the pore can be saturated with respect to  $\text{Fe}_3\text{O}_4$  at the in situ pH level. As one proceeds up the pore, the hydrogen discharge reaction will create alkalinity, hence, there will be a variable solute concentration up the pore — the alkalinity rising to a maximum and then tapering off to the bulk solution value at the solution end of the pore. This alkalinity gradient would be expected to lead to a magnetite dissolution along pore walls and reprecipitation further along the pore toward the oxide solution interface. Such a picture is in accord with the conclusions of Castle and Masterson (11) that solution transport of soluble iron is the dominant factor in the development of films in the Potter and Mann type of experiment. It also would provide a mechanism for iron transport in films developed in capsules.

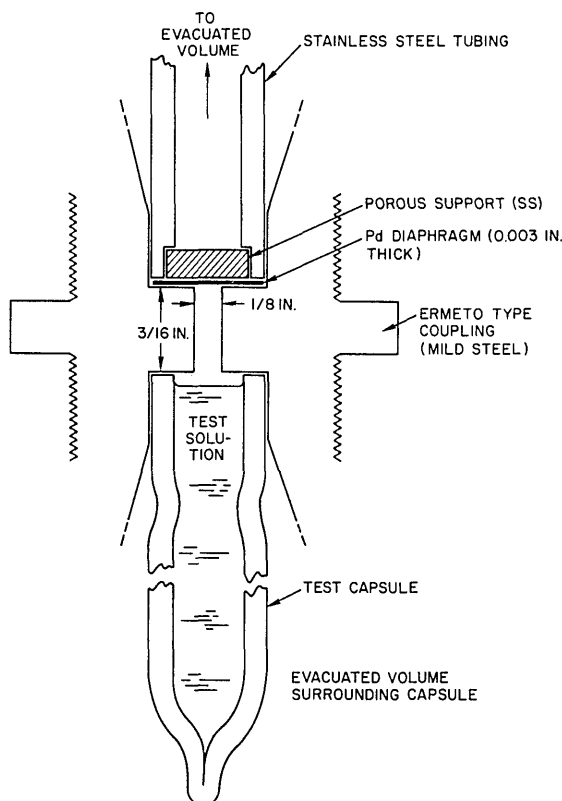
In accordance with the above reasoning, the apparatus in Fig. 2 was constructed. The test capsule of 0.030-in. wall tubing, with the same composition as used routinely in this laboratory for hydrogen-effusion-type corrosion rate measurements,\* had an internal volume of 1 cc and was filled with enough solution to expand to slightly less than 1 cc at the test temperature (300°C). An attempt was made to provide insulation between the palladium-silver alloy diaphragm† and the metal of the coupling to prevent a galvanic effect, but this was unsuccessful. Comparison of experimental data with previous effusion experiments made by the NRL technique (8) indicated some augmentation of corrosion rate attributable to this effect.

The apparatus of Fig. 2 was immersed in an evacuated container of known volume and heated to 304°C. The tube leading from the palladium diaphragm also connected to an evacuated container of known volume. The pressure in the vacuum spaces was monitored by Pirani gages with recorders, the Pirani units having previously been calibrated with hydrogen using a McLeod gage as a primary standard.

It was determined that the palladium diaphragm would function like a window to hydrogen by imposing a hydrogen pressure differential of 1 atm on it and measuring the rate of permeation at 304°C. A flow of 3.84 cc/hr, equivalent to a corrosion rate of ca. 60,000 mg iron/dm<sup>2</sup>-mo, was found. This is more than 30 times the amount of hydrogen which would permeate the bare capsule wall at this pressure and was considered ample for the range of rates expected in the experiments.

Fig. 2 - Palladium-alloy  
"window" apparatus

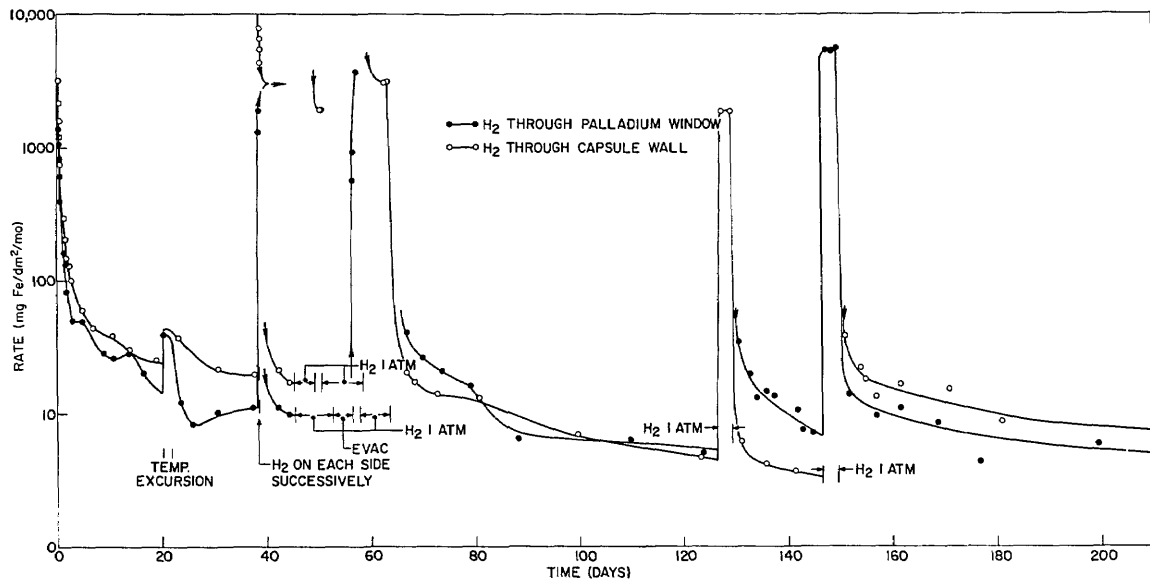
It was realized after experiment 1 had been underway for 38 days that information of potential value could be obtained by measuring the rate of hydrogen permeation from one side of the system to the other with a known pressure differential. This was done by using 1 atm of hydrogen pressure at selected times in each experiment, except experiments 2, 5, and 6, and the resulting hydrogen flows in terms of mg Fe/dm<sup>2</sup>-mo are included in Figs. 3. These measurements (summarized in Table 2) necessitated interruption of corrosion data collection for periods of 4 or more hr to allow equilibration. (It can be seen in Fig. 3a that the data from 38 to 58 days were taken too hurriedly to reach equilibrium.)

(a) 15% sodium hydroxide solution (experiment 1)

Fig. 3 - Corrosion rate-vs-time data

In experiment 1 there appears to be an appreciable dependence of the hydrogen permeation rate on its direction of flow (ignoring the first two points, which were not equilibrated). This is believed to be caused by the physical requirement of dissolution in the electrolyte at a small area interface, plus convection or diffusion to the oxide film in one direction, whereas the hydrogen coming in through the capsule wall could simply bubble up through the electrolyte and leave via the palladium window. In other experiments the barrier at the oxide film was great enough to mask this effect.

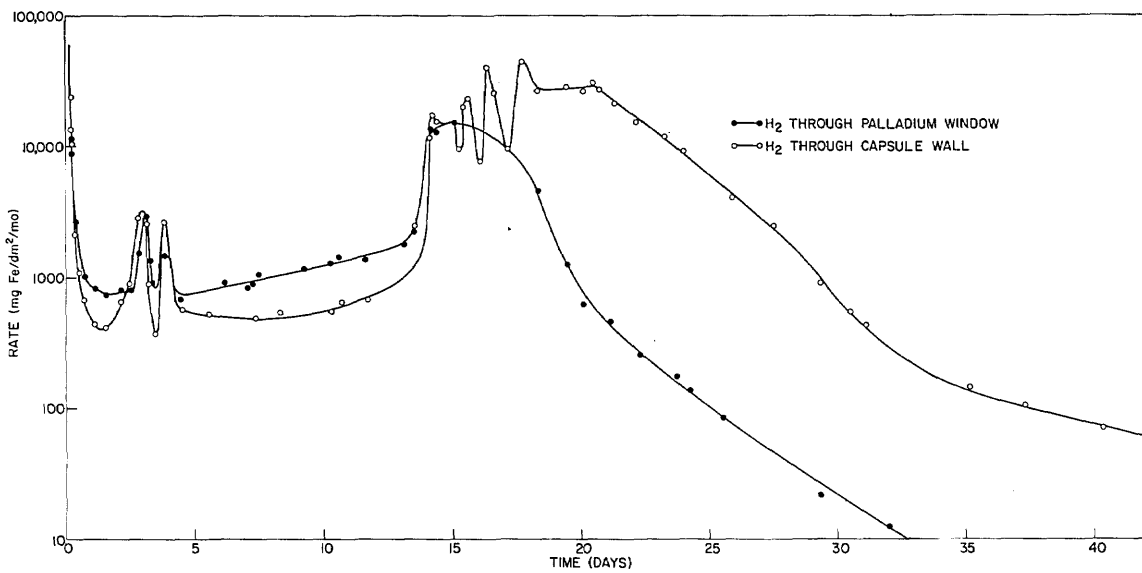
The second experiment was with a 40% sodium hydroxide solution, and approximately 4 hr of heating preceded a successful start. This strong solution was used because it was known to cause pitting fairly quickly. A possible reason that pitting progresses without healing might be that a great enough quantity of hydrogen is evolved in such a small area that gas bubbles form and blow back out of the pit to be dissipated by permeation through the ample available metal wall area elsewhere. This hydrogen should be seen coming through the palladium window in a disproportionate quantity.

The experiment was not successful in answering the pitting question due to a series of complications. Perturbations appearing in the third to fifth days were attributed to invasion of metal-to-metal seals by the electrolyte, evidence of which was provided by sectioning and examining by microscope. The reason for the sudden rate increase at 14 days remains unknown. The wide difference between flows after 17 days was caused by the development of a solid plug of magnetite in the neck of the apparatus. Another complication was that all the water was chemically consumed some time before the experiment ended.

(b) 40% sodium hydroxide solution (experiment 2)

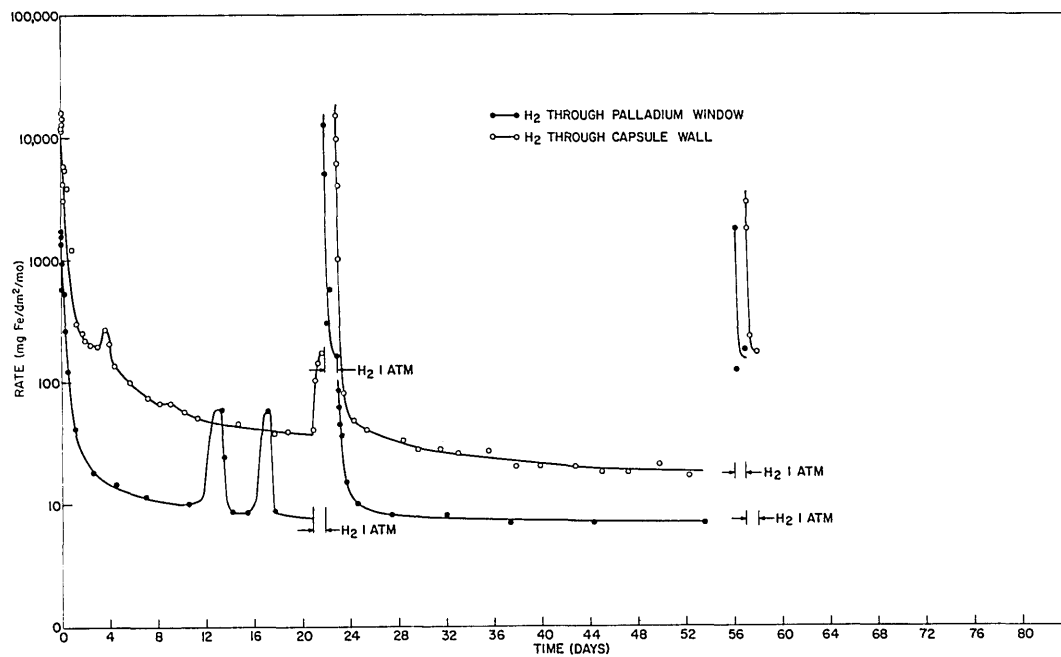
(c) pH 11 lithium hydroxide solution (experiment 3)

Experiment 3 with a pH 11 lithium hydroxide solution was conducted without difficulty as was experiment 4 with a pH 11 sodium hydroxide solution. There was some question concerning an undue amount of contamination of the latter solution by carbonate; pH readings were ambiguous, but a reading after the experiment confirmed previous evidence that alkalinity in sodium hydroxide solutions remains constant or rises slightly because of water consumption.

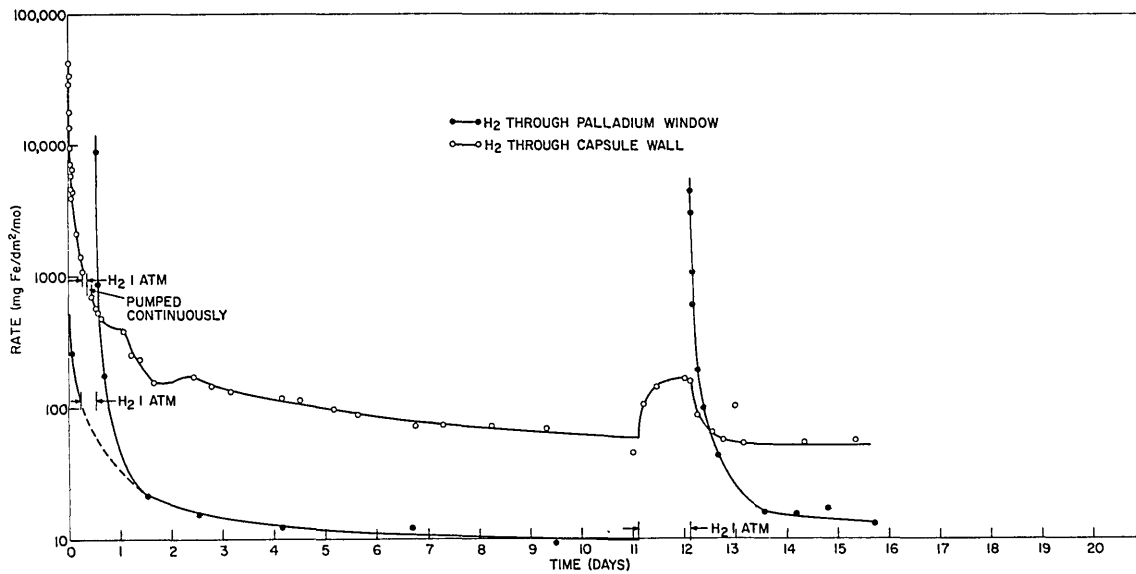
(d) pH 11 sodium hydroxide solution (experiment 4)

A very interesting feature of this system with regard to hydrogen permeation was exposed by the first permeation datum of experiment 4 (ph 11 sodium hydroxide). The palladium window side of the apparatus was pressurized to 1 atm with hydrogen at only 1/2 day's elapsed time, and no augmentation of flow through the capsule wall was evidenced. Instead, two additional points fell right on the corrosion rate curve for the capsule side, i.e., 710 and 570 mg Fe/dm<sup>2</sup>-mo. The fact that no additional flow was observed here would seem to indicate at first glance that the hydrogen dissociation equilibrium,  $H_2 = 2H$ , was satisfied at the oxide/metal interface with the molecular hydrogen equilibrium pressure at some value higher than 1 atm. However, the situation is a dynamic one, not conducive to the development of equilibria but rather only steady-state conditions. Therefore, it seems unwise to invoke the presence of molecular hydrogen in any specific amount.

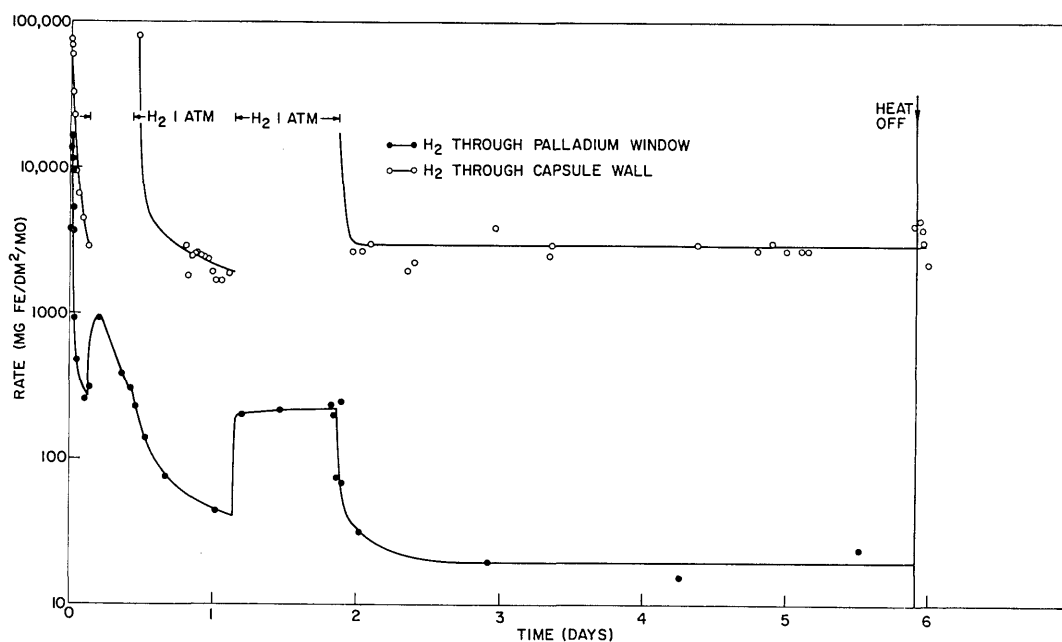
(e) pH 11 lithium hydroxide solution (experiment 6)

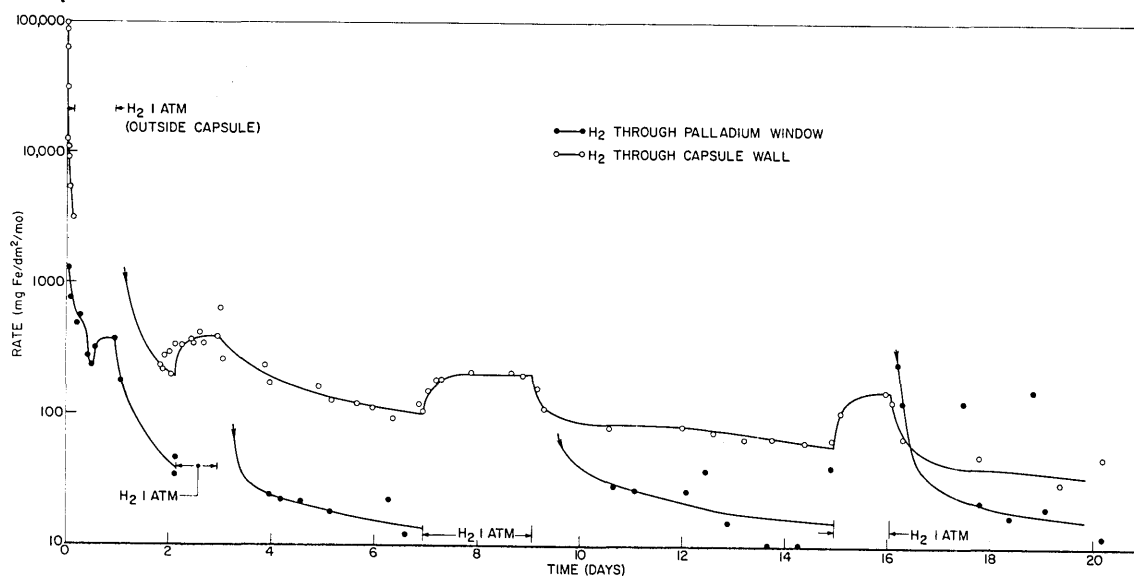
(f) pH 11 lithium hydroxide solution (experiment 7)

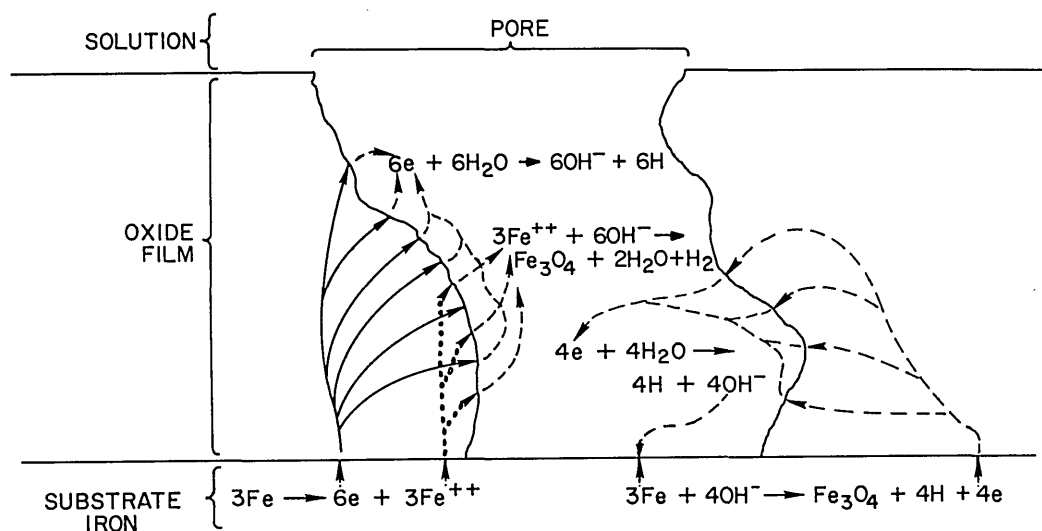
Fig. 4 - Probable boiler corrosion mechanism

The reasons dictating the partitioning between the two processes will require further analysis. It probably depends on the dimensions and frequency of pores and on the actual relationship between pore base area and total area of iron.
